Greene, Tweed Composite Technology

Comparison between AR[®] and Thordon[®] materials

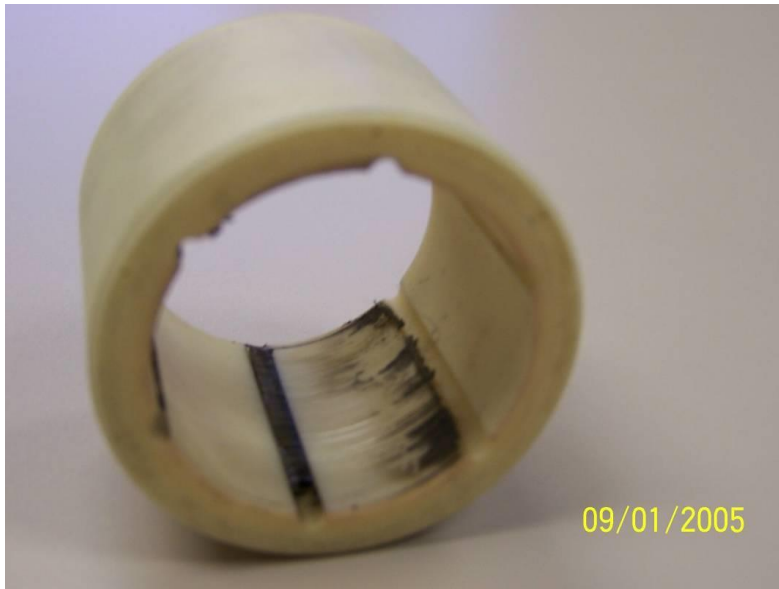
Comparative Results

Synthetic Polymer Alloy 304 SS Shaft

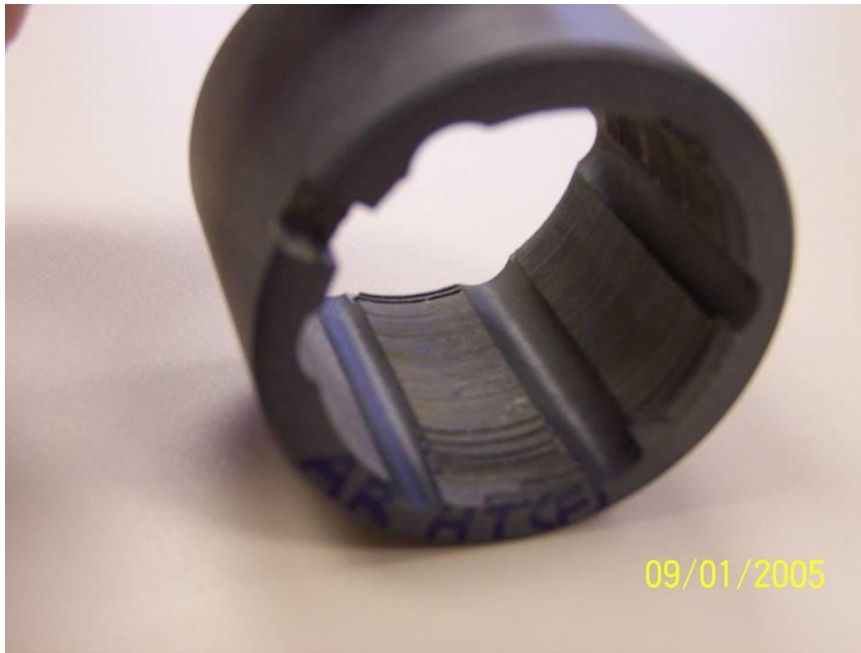
Comparative Results

Abrasion Resistant AR[®]HT 304 SS Shaft
