1. ABRASION RESISTANCE TEST

Product Test Laboratory

2. DRY RUN TESTING

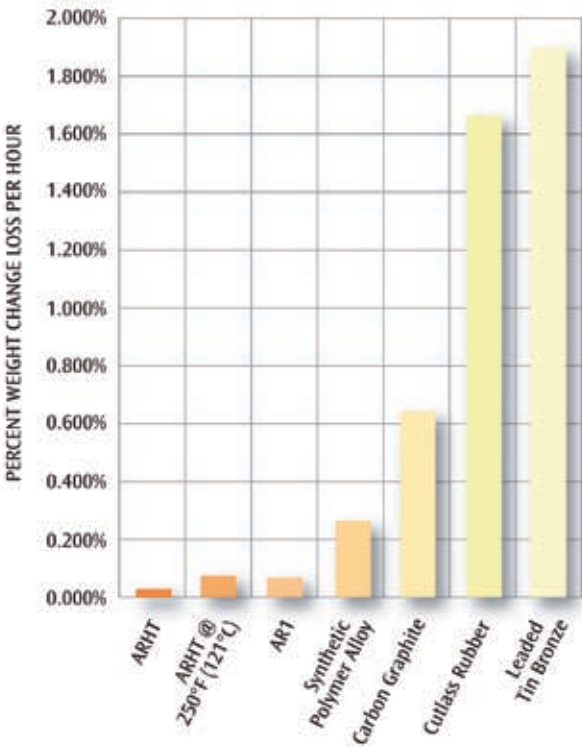
The chart shows percent weight change (loss) per hour of Greene, Tweed’s AR materials compared to traditional materials. As shown in the data, Greene, Tweed’s ARHT and AR1 are less damaging to the shaft or shaft sleeve in abrasive media than traditional bearing materials.

AR® composites are less damaging to the shaft or shaft sleeve in abrasive media over traditional bearing materials such as cutlass rubber.

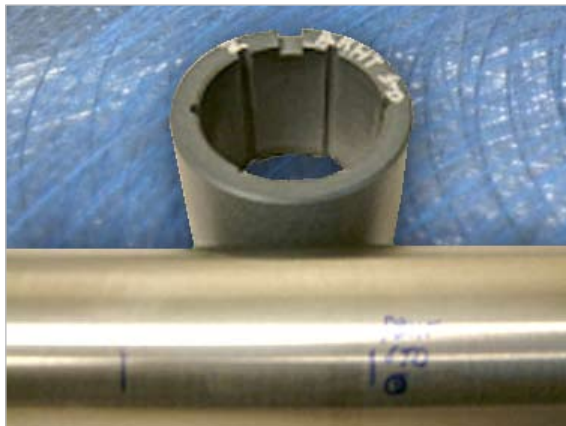
ARHT

Excellent condition of bearing/rod

AR®1/ AR®HT: No change in cross section, inner diameter, or weight loss. Bearings and rod look practically new.

Pictures below show bearings and rods after two minutes of dry testing @ 1666 RPM.

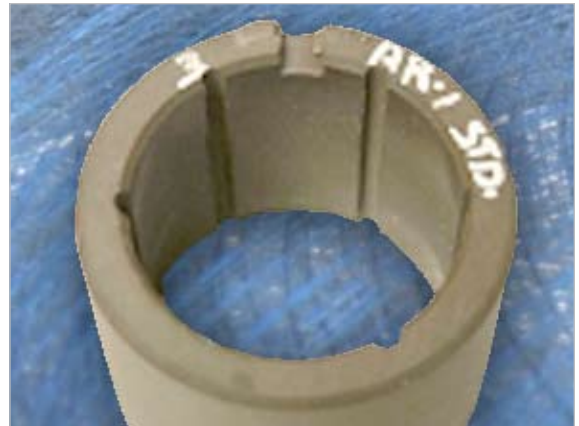
AR1

Unaffected

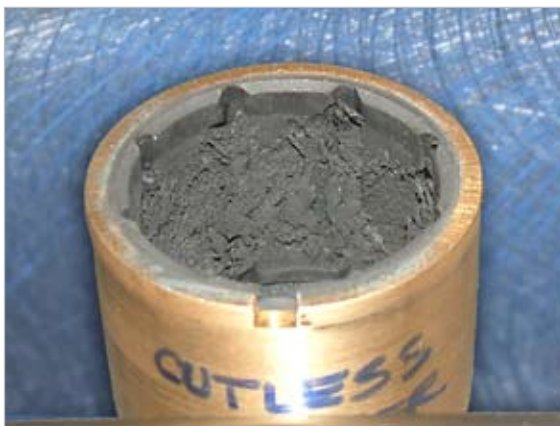
Duramax Cutless Rubber

Severe wear; after 20 sec excessive vibration, black smoke & motor rpm dropped drastically.

Cutlass Rubber: Only for 20 seconds running

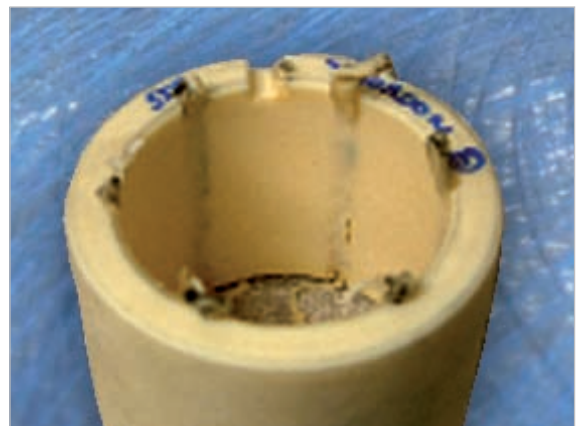
Thordon SXL

Worn cross section & inner diameter; grooves completely filled with excess material; slivers of material extruding from the grooves.

Thordon SXL: Grooves completely filled with excess material. If emptied weight loss values would clearly increase >1%.
